CALIFORNIA DIVISION OF MINES AND GEOLOGY

Fault Evaluation Report FER-13

April 18, 1978

Name of fault: Ventura fault.

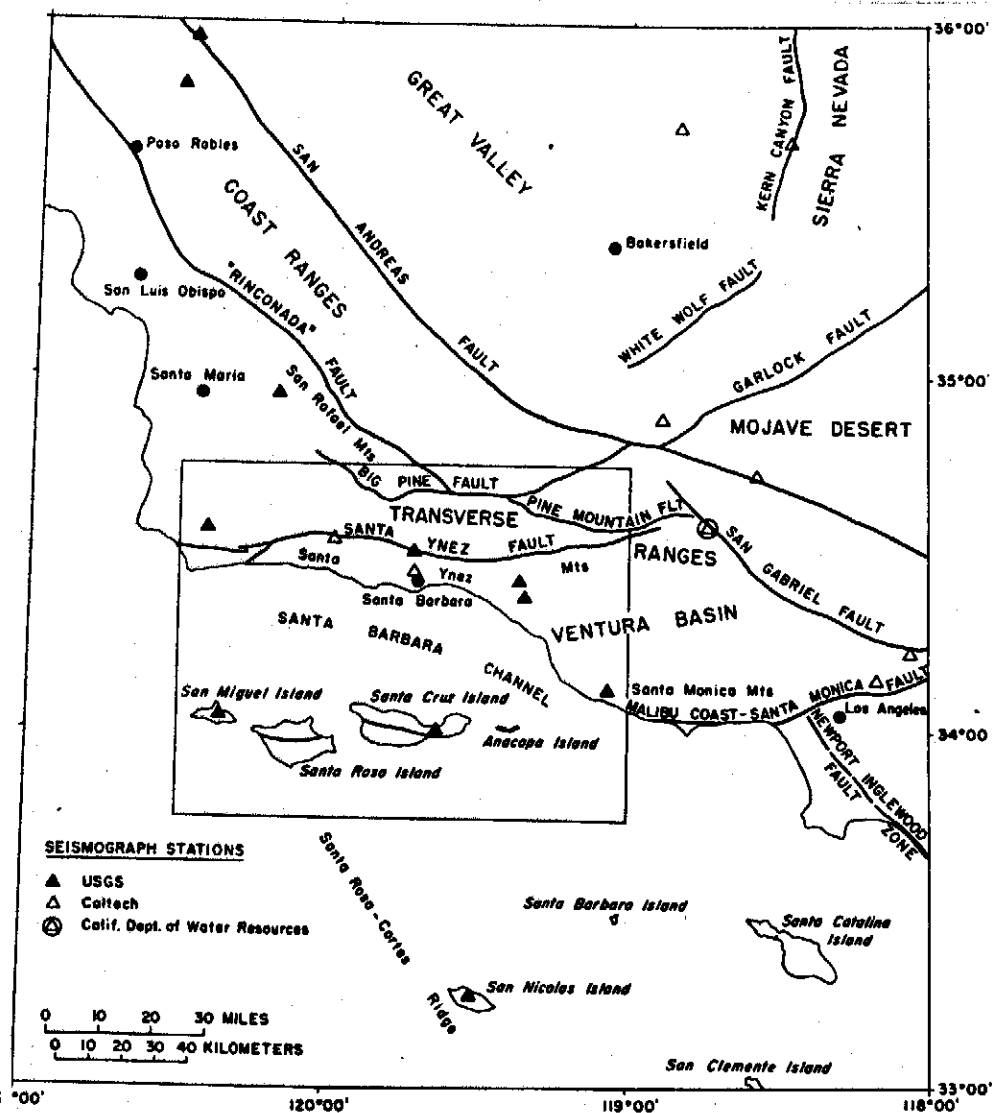
Fig. 3. Index map showing location of seismograph stations, selected major faults, and geomorphic provinces with respect to the Santa Barbara Channel region (boxed area). (From ~~Vedder, 1973~~, Lee and Vedder, 1973, p. 1758.

located network of seismographs (figure 3). Lee and Vedder noted significant differences between the locations of the same 25 earthquakes as determined by the two teams (figure 4). It is logical to consider the U.S.G.S. locations (and their ^{derivation of the} senses of displacement) as the better data.

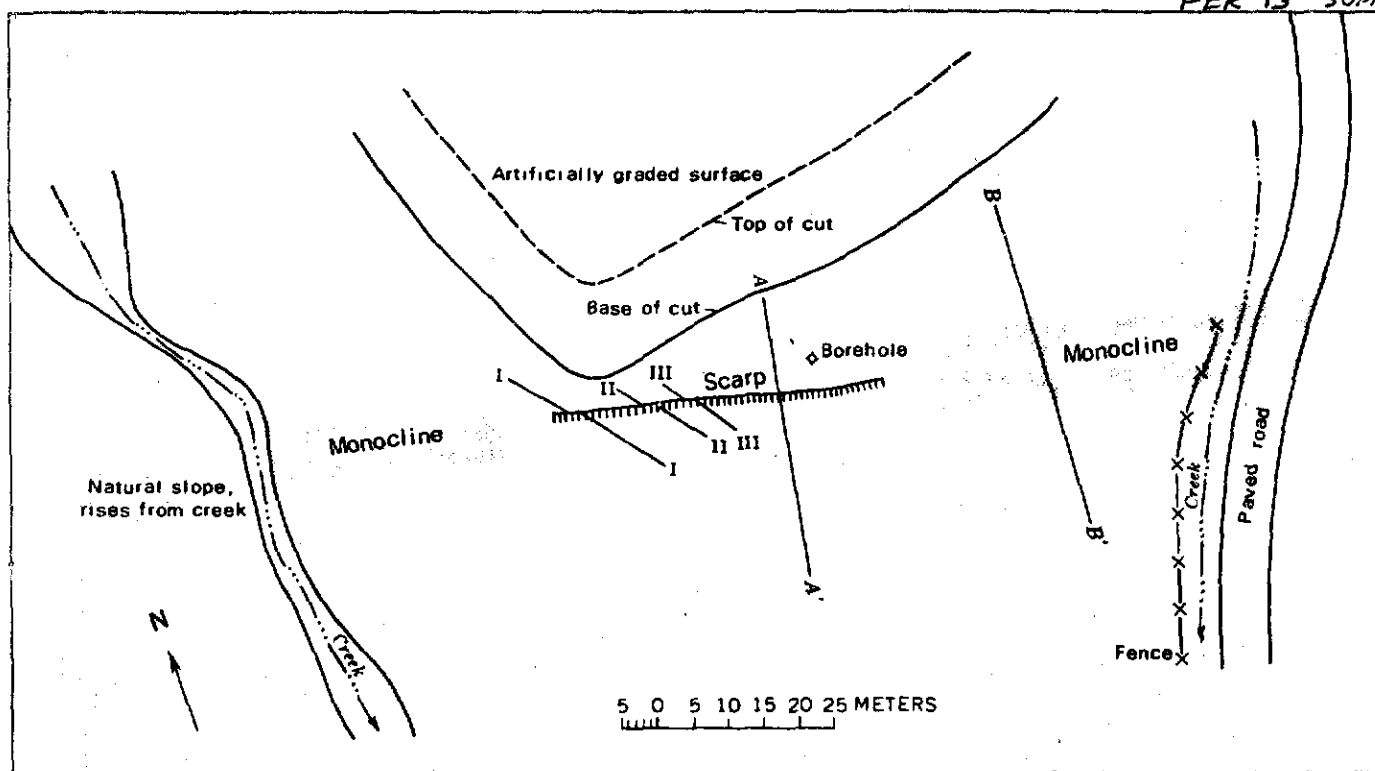
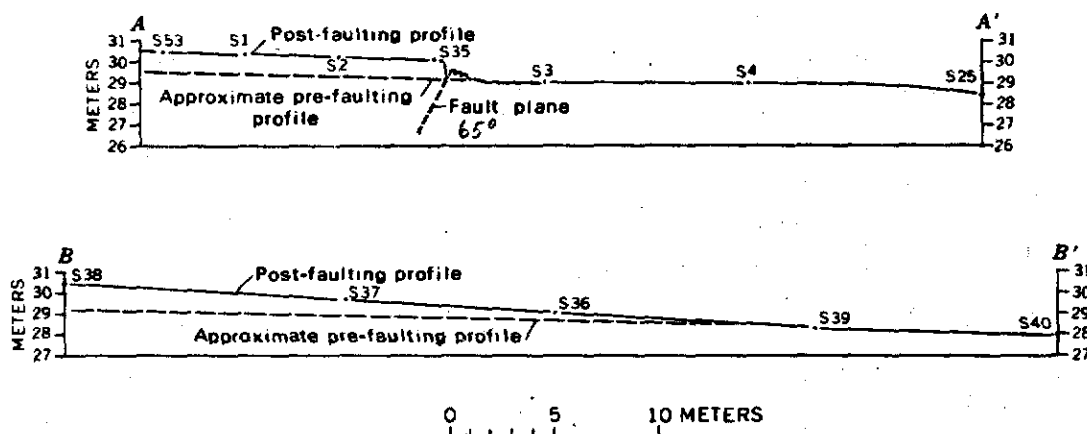
FIGURE 5.—Plan and profiles of trace of fault 0.9 km north of mouth of Lopez Canyon, based on planetable mapping. For location see figure 2. Elevations on profiles referred to local assumed datum. Numbers preceded by S are field survey stations. (From Bonilla, et al., 1971, p. 69).

One could argue whether the Ventura fault is actually a fault or a monocline. At the surface it is a monocline. More precisely, it is a faulted monocline, and has apparently been uplifted and faulted during the Holocene. During the 1971 San Fernando earthquake, near Lopez Creek a case was noted where a fault "died out" at either end in a monoclinial fold (Bonilla, et al., 1971; see figure 5). The implications are
